Comparing the Costs of Three Stream Restoration Projects Constructed on Mill Creek between 2004 and 2007 in Lower Merion Township, Pennsylvania

M. C. LeBoon¹

¹F. X. Browne, Inc., Lansdale, PA 19446; PH (215) 362-3878; email: mleboon@fxbrowne.com

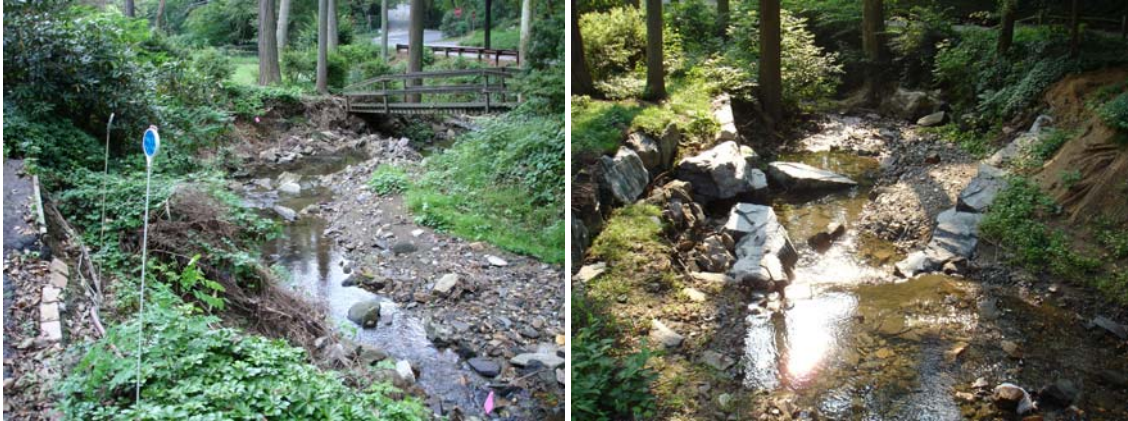
Figure 1: Project #1 Stream Condition Before and After Construction

The first project was to restore a 160 foot stretch of creek with severe incision and bank failure. The erosion was threatening the driveway that crossed over the creek and a large headcut was caused by a dam failure that occurred downstream during the storm. A gully had also formed on the right bank, just downstream of the driveway, which was destabilizing the bank in that area.

Figure 1 shows the project area before and after the various stream restoration measures were installed. The erosion on the left bank is very evident in the picture on the left. The picture on the right shows the cross-vain and the geo-grid that were installed.

A number of stream restoration and stabilization measures were installed along the stretch of the Mill Creek. The section of the bank that was most severely eroded was also the area with the least vegetative cover. A boulder toe was installed along the length of the left bank in order to withstand the high velocities and shear stresses in that area. Above the boulder toe, a vegetated geo-grid was used to reduce the grade in that area and provide vegetation along the bank. In the area where the gully had developed, coconut fiber biologs were placed along the right bank to act as check-dams for runoff coming down the slope. Due to the full shade of the project area, a shade tolerant native seeding mix was used throughout the entire project. Approximately midway down the length of stream, a j-hook was used to direct the water flow back into the middle of the stream channel and away from the bank as well as to deepen the channel. Finally, a rock cross

vain was constructed in the area of the headcut to stabilize that are and prevent the headcut from moving any further upstream.

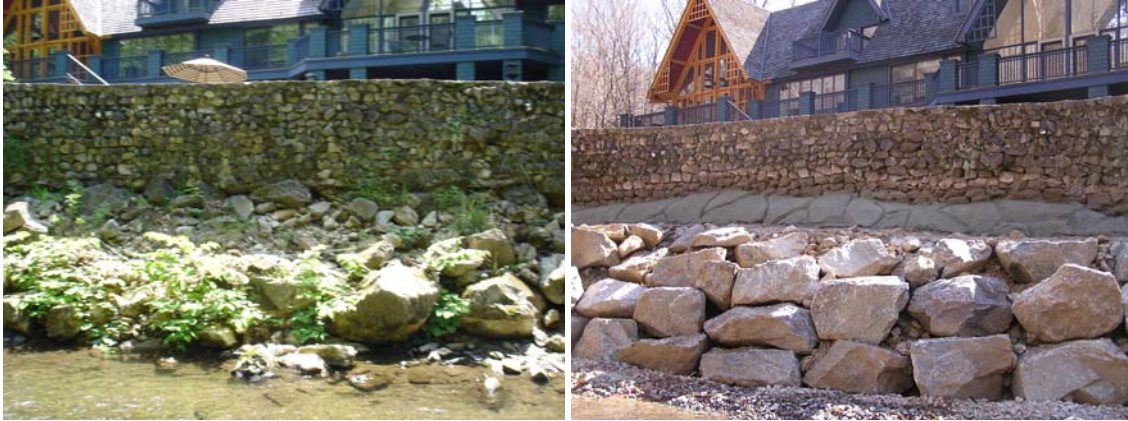
Figure 2: Project #2 Retaining Wall Before and After Restoration

The second project area was 310 feet long and had the least amount of damage to the stream channel. The main concern was that the existing masonry wall which supports the patio and pool area was being undermined by erosion and scour.

Figure 2 shows the retaining wall and stream bank before the construction. The wall was being undermined by during high flows and the banks had little vegetation to protect from erosion. The picture on the right shows

A concrete footer was constructed to stabilize the existing masonry wall. Boulders were placed on top of riprap gabions set into the stream bank to the depth of maximum scour to stabilize the slope from the existing wall to the stream bank. A rock J-hook was placed upstream of the masonry retaining wall and eroding stream bank in order to redirect the stream flow and move the thalweg away from the eroding bank and into the center of the channel. This should cause the channel to deepen which will allow for energy dissipation. Two additional J-hooks were constructed along the length of the stream to maintain flow in the center of the channel, away from the eroding banks.

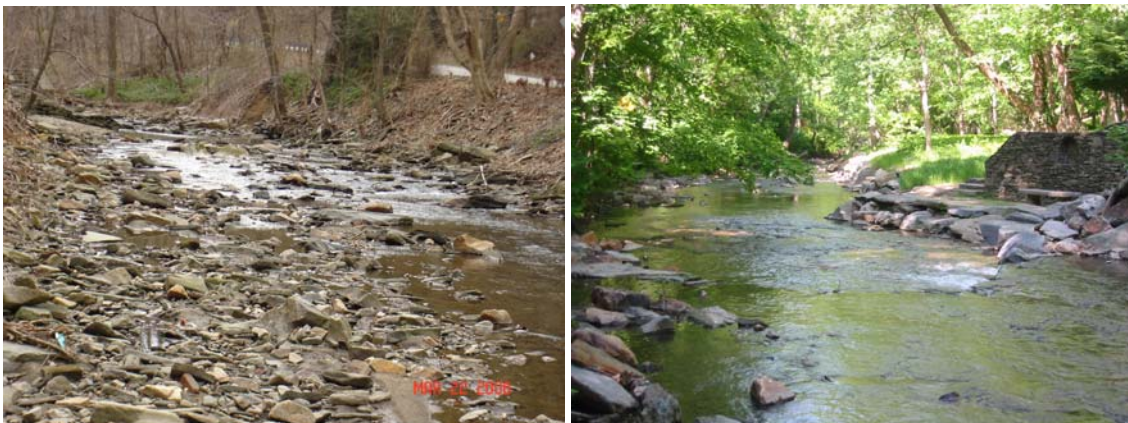
Figure 3: Project #3 Before and After Stream Restoration

The final project included the restoration of a 450 foot length of the Mill Creek. A gabion basket wall located upstream of a stone patio was preventing stream bank erosion along the eastern bank of the creek. The wall, however, was directing high flows toward the opposite bank and causing erosion in that area and undercutting areas exposing the roots of small trees. A patio juts into the stream channel only a few feet from the thalweg of the stream downstream of the gabion wall, causing large boulders to be deposited in the area. This has prevented the channel from deepening over time which has caused both banks down stream of the patio to be severely eroded.

A J-hook was installed at the upstream end of the patio area to relocate the thalweg to the center of the channel, reduce stress on the bank and deepen the channel for energy dissipation. A boulder toe was constructed along the eroded area on the left bank, across from the gabion wall and the slope was re-vegetated. Downstream of the patio, along the right bank, the stream bank was stabilized with a system of natural boulder toes placed randomly to create a natural appearance. Vegetated geo-grids were interspersed between the sections of boulder toe as well as above the boulder toe wall to reduce the grade in that area and re-vegetate the bank.
