Effectiveness of BMP Controls Study

FINAL REPORT

Lake Wallenpaupack Watershed Management District

FY1999 EPA Grant Task 2

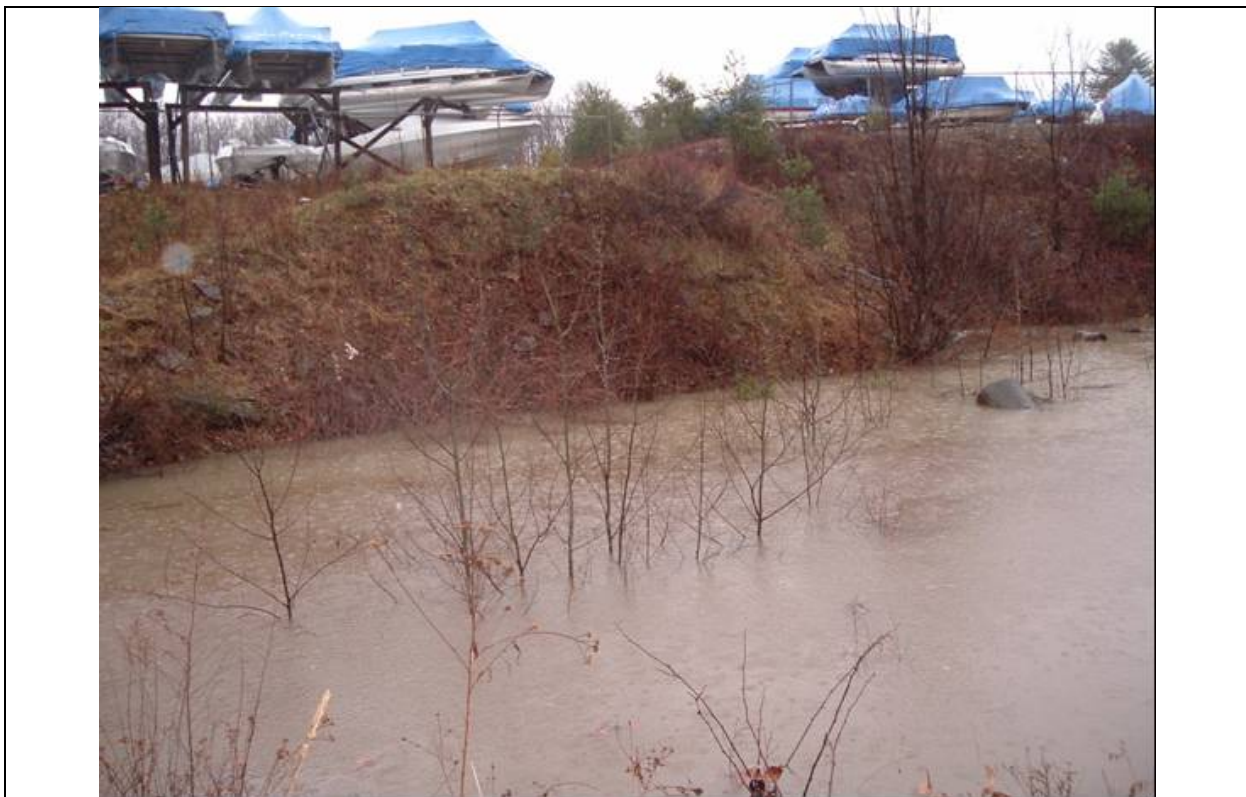
Poorly-functioning Detention Basin Adjacent To Bakker Marine Before BMPs Installed

Bakker Marine is located in Paupack Township, Wayne County, PA. The marina has a large paved parking lot and covered boat storage area. Stormwater from these impervious areas was running off the site and causing erosion and flooding along roadsides in the Walt's Landing development, as shown in the photos below. A detention basin existed on the site but was not functioning properly, leading to excessive sheet flow across area fields and right into lake. Many area homes had flooded basements and property damage during heavy rains.

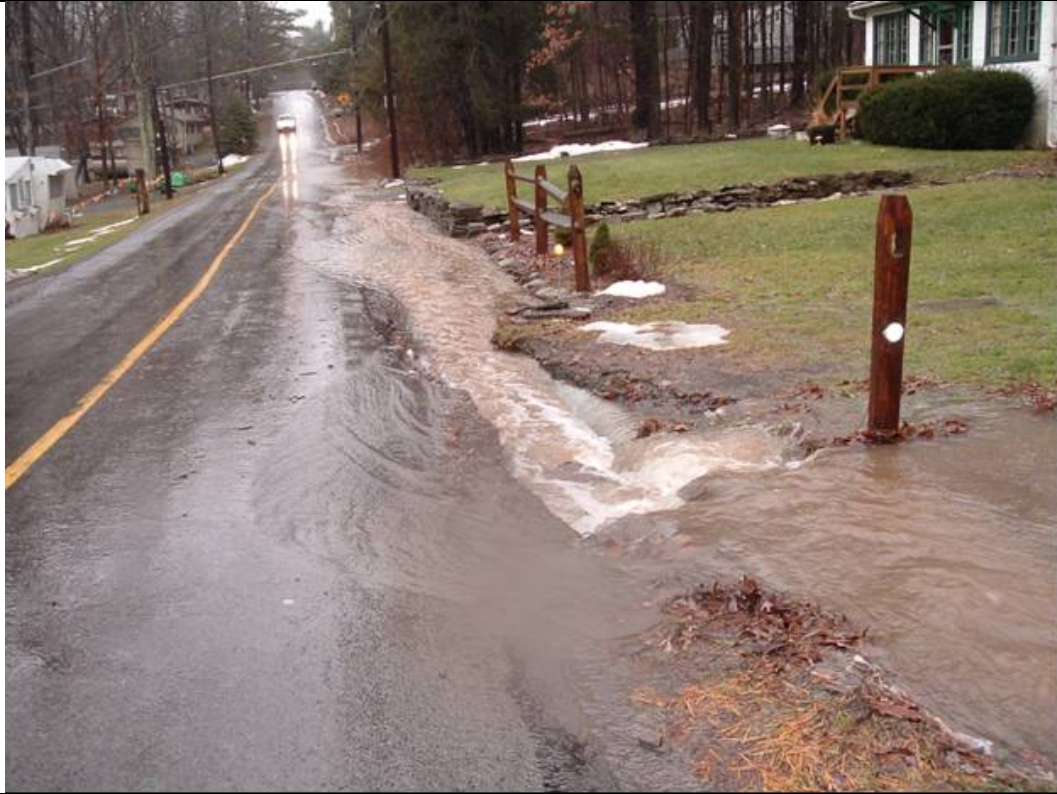
Roadside and Flooding during rain event before BMP installed

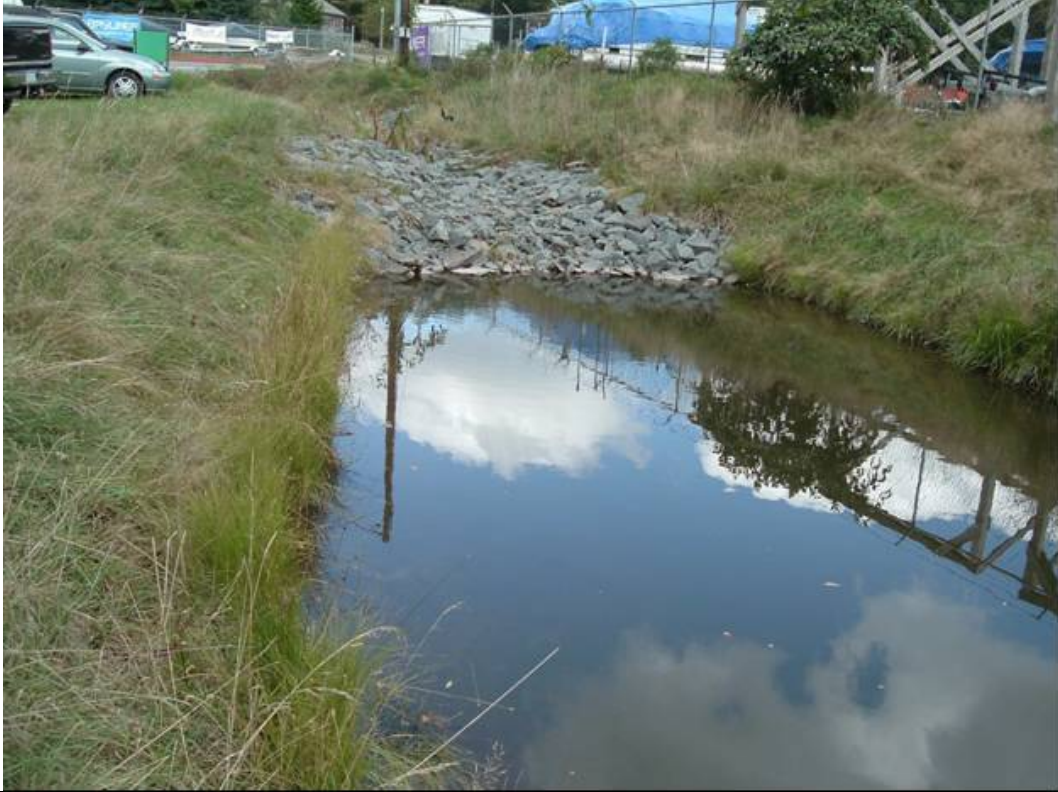
Sediment Forebay at Constructed Wetland Inlet

For the project, the existing detention basin was converted to a constructed stormwater wetland system to receive and treat the site runoff. The project was constructed in 2000. The wetland consists of six sediment forebays and a large basin. The outlet of the wetland is directed into a rock channel along the roadside. The goal of the BMP is to not only slow the stormwater velocity, but also to retain some stormwater for nutrient and sediment removal and peak flow reduction. The photos below show the constructed wetland post-construction and after wetland plant establishment.

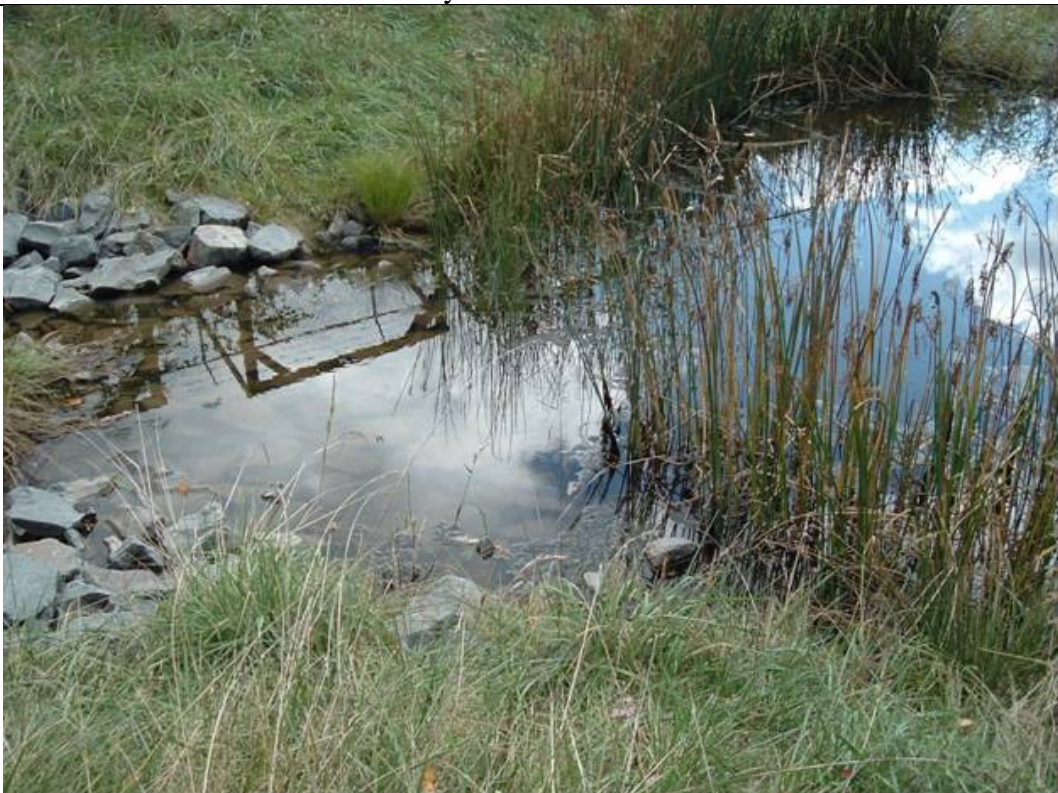
Wetland Plantings Help Filter Stormwater and Trap Sediment

It should be noted that it took several years for the wetland plantings to become well established, but they are thriving now.

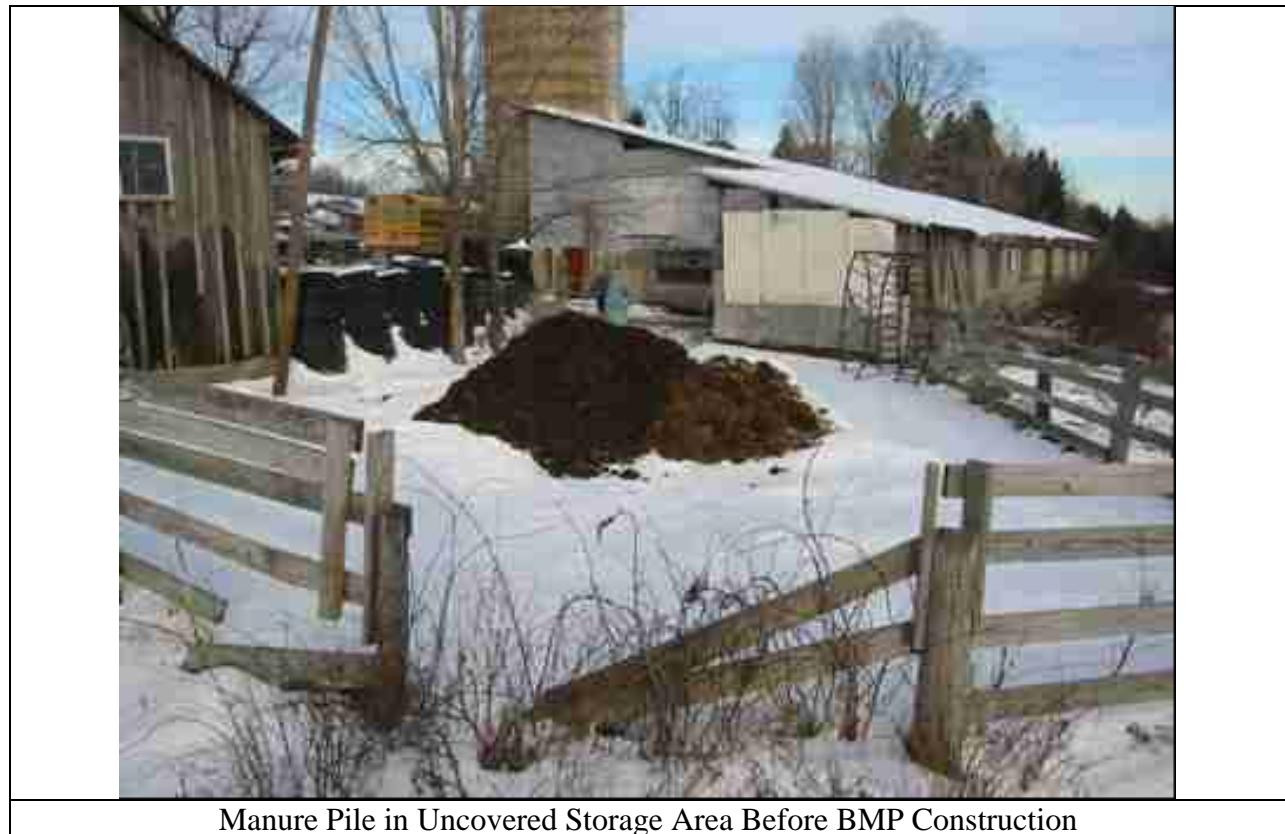
Manure Pile in Uncovered Storage Area Before BMP Construction

The Carroll Krautter farm is located in Greene Township, Pike County, PA. The farm primarily raises livestock. The farm had lots of open manure piles and loose soils, as shown below.

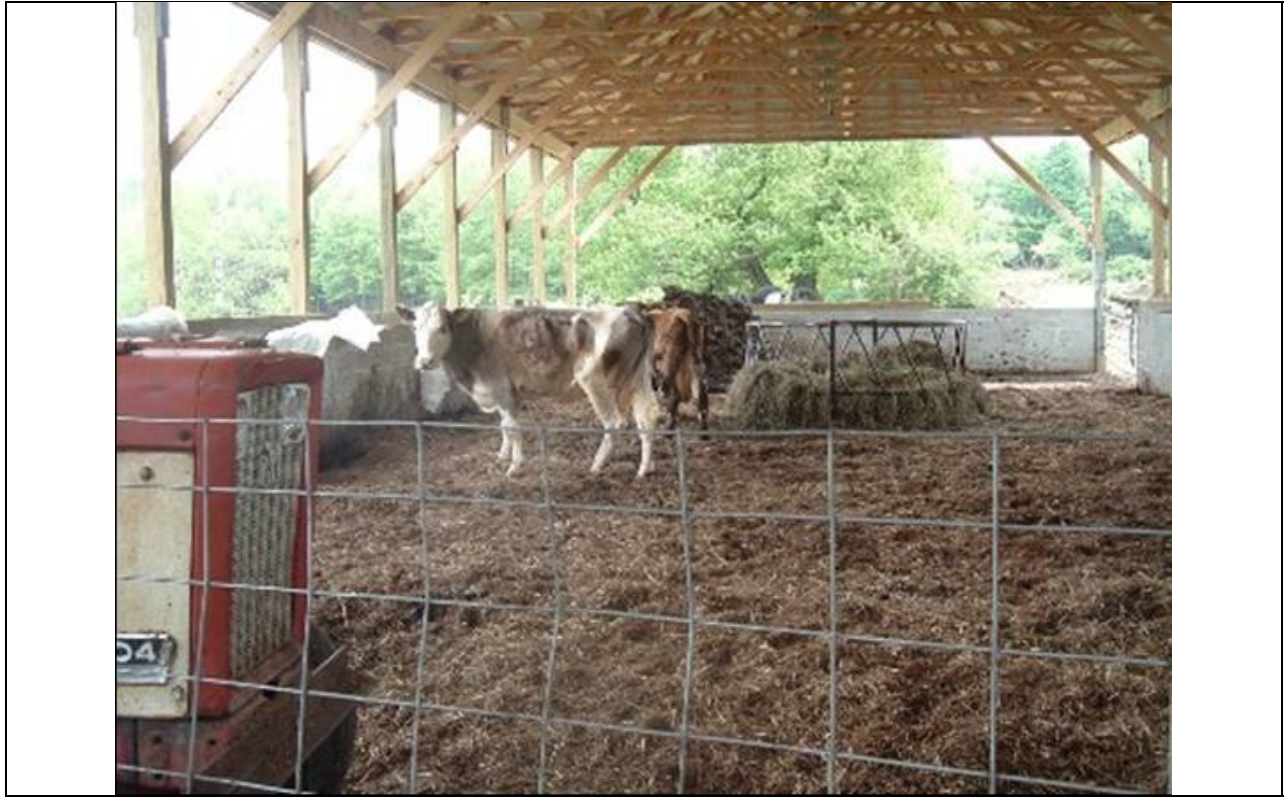
Inside of Agricultural Waste Facility Post-Construction

Krautter farm is located near a pond and a tributary to Wallenpaupack Creek. As part of this project, an agricultural waste facility with a roof was constructed, as shown in the photo below. In addition, water diversion and heavy use area protection was installed on the property.
